Case Study

CWST Relining

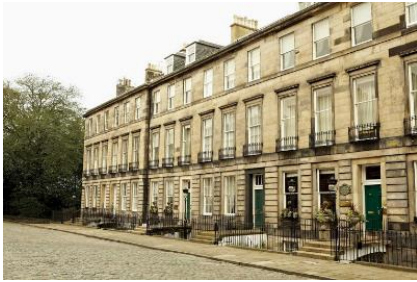
- Risk Assessment identified corroded non-compliant water tanks
- DMA Canyon advised replacement or relining of tanks which fed bars, restaurants and residents rooms (including showers)

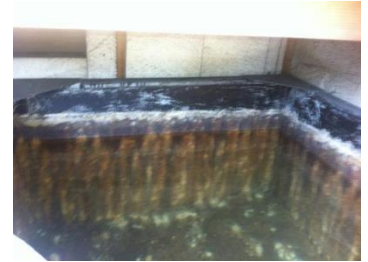
DMA Canyon plumbing consultants attended site to investigate the options for replacing or upgrading the tanks

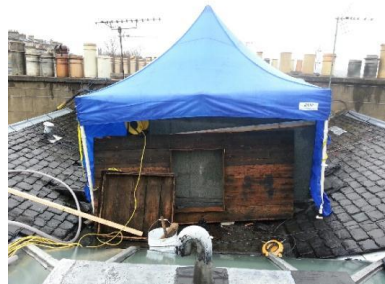
- External water tanks on 4th storey roof
- Poor access
- Tank replacement very costly and impractical
- Tanks linked together
- Hotel had to remain open during works

On investigation it was agreed with site that relining of the tanks was the most practical & cost effective option.

- DMA Canyon re-plumbed system to allow each on tank to be worked on individually to keep hotel operational at all times
- Other trades sub-contracted to create access to tanks and temporarily seal roof
- CWSTs re-lined whilst in-situ with a WRAS approved coating with no disruption to hotel or guests
- DMA Canyon completed plumbing remedial works and upgrade of water tanks to ensure L8 compliance
