Case Study

Bacterial Contamination Reduction Through Background Dosing

DMA Canyon Ltd were requested to carry out an L8/SHTM 04-01 legionella risk assessment on a high profile acute medical care building in Glasgow

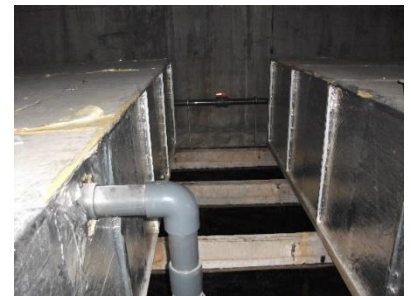
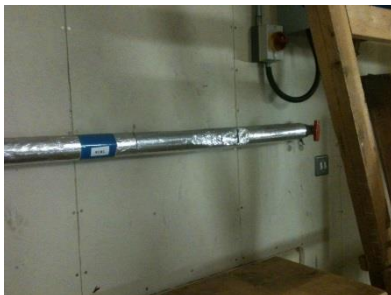
1960s building which has had numerous alterations to the water systems over time, creating a non-compliant system

Consistent out-of-specification microbiological results (including legionella)

Poor temperature control in both hot and cold water systems

Plumbing remedial actions required throughout the building

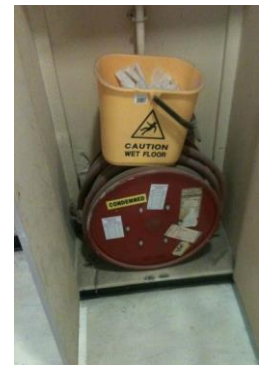
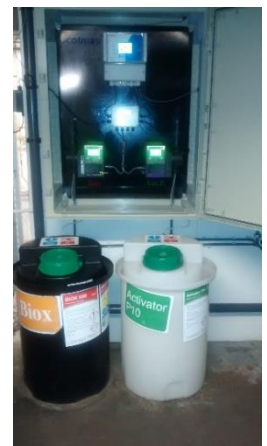
DMA Canyon managed a works package to facilitate the installation of a bespoke chlorine dioxide (ClO₂) dosing system with gas monitoring, auto alarms and remote monitoring.

This has resulted in a significant improvement in the microbiological control within the water systems
